TECH TRENDS

*The Applied Technologies
Newsletter for Superfund
Removals & Remedial
Actions & RCRA Corrective
Action*

"Snow Cap" Used for Sediment Remediation

EPA 542-N-99-003
May 1999
Issue No. 33

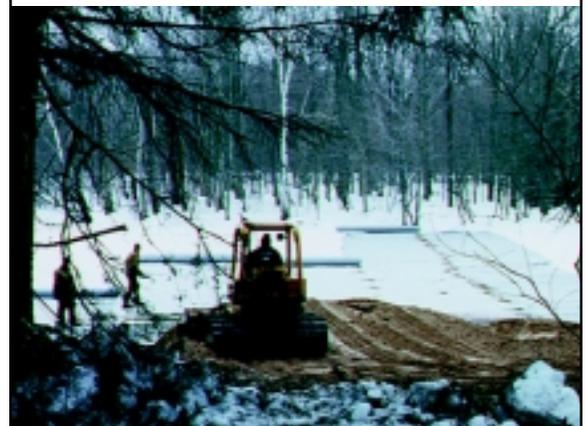
Figure 1. Spreading Geotextile over Frozen Lake

geotextile and sand blanket over the impacted area, and a second layer of geotextile and rock "islands." The geotextile keeps sediment from migrating into the sand, and sand from migrating into the rock "islands" that serve as a spawning habitat. Snowmobiles were used to pack the snow and increase the ice thickness from 6 to 24 inches, thus providing support for heavy, wheeled construction equipment. By constructing the cap on top of the frozen lake, the creation of a "mud wall" (typically formed when water capping begins at a shoreline and pushes the cap materials outward over the sediment) was avoided. The formation of such mud walls commonly re-suspends contaminated sediment and prevents adequate contaminant containment. Installation of the cap on top of the frozen lake also allows the geotextile to be spread during a longer time frame, overlapped uniformly, inspected prior to covering, and placed without sediment disturbance (Figure 1).
